**Geotechnical Pavement  
Investigation,  
Moosonee Airport, ON**

The Corporation of the Town of  
Moosonee, ON

May 11, 2015

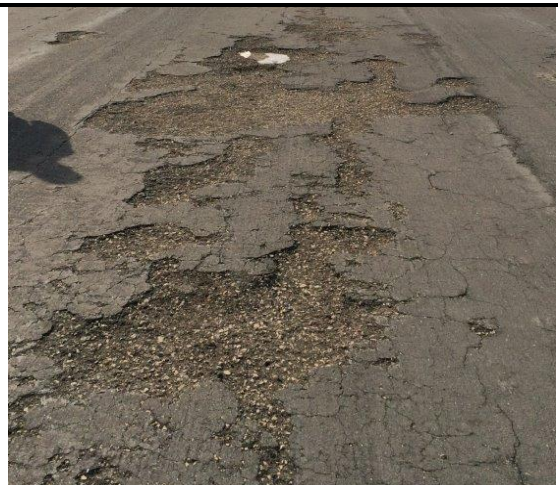
**Figure 1** Surface Raveling in Location with Micro-surfacing

There are several isolated high-severity pavement raveling areas within the micro-surfacing mostly on Runway 06-24 but also evident on Taxiway A. A typical example from Runway 06-24 is shown in **Figure 1**.

The micro-surfacing layer, as well as the surface of the underlying dense graded cold mix asphalt, has debonded from the pavement. The exposed remaining asphalt layers are generally very soft (can easily be dug by hand) and the asphalt cement has visibly stripped from most of the exposed aggregates.

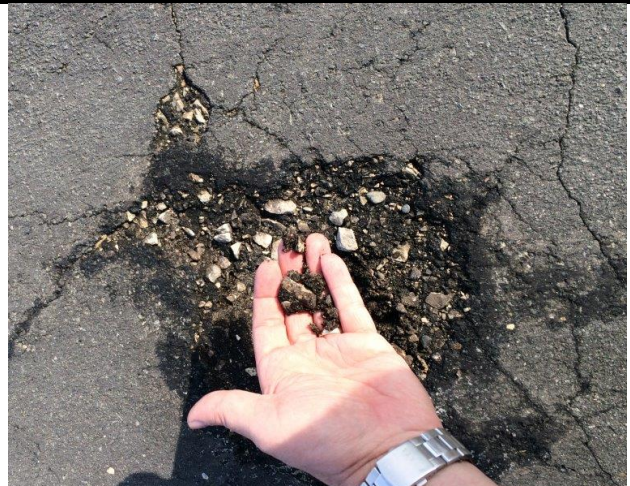
**Figure 2**      **Soft Asphalt in Raveled Areas on Runway 06-24**

It is important to note the poor quality of the exposed asphalt pavement at the raveled areas on Runway 06-24. The condition is best illustrated by the photo in **Figure 2**.

In many of the areas where the micro-surfacing has raveled from the pavement surface, the underlying dense-graded cold mix asphalt is very soft and can be removed by hand.

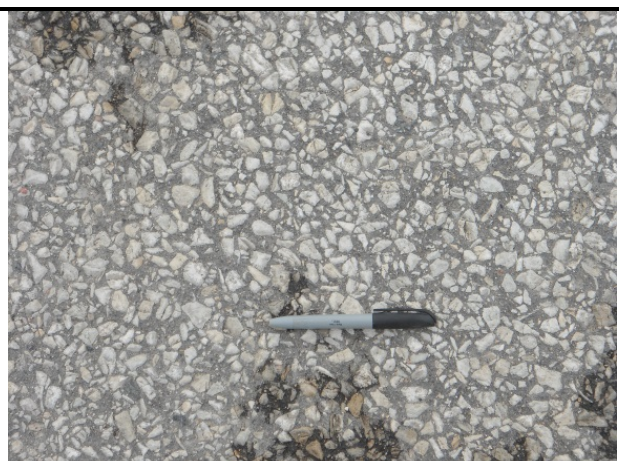
**Figure 3**      **Surface Raveling in Location without Micro-surfacing**

As noted above, a portion of the Main Apron did not receive an application of micro-surfacing in 2007 and high-severity surface raveling was observed over most of the surface (a portion of the surface was snow covered at the time of the investigation). **Figure 3** provides a photo of the raveled surface where micro-surfacing was not applied.

High severity surface raveling in an area without micro-surfacing. The exposed surface is extremely raveled and the asphalt cement has stripped from the surface of the exposed asphalt pavement. The condition differs from raveling at micro-surfaced locations in that the underlying asphalt pavement is sound.

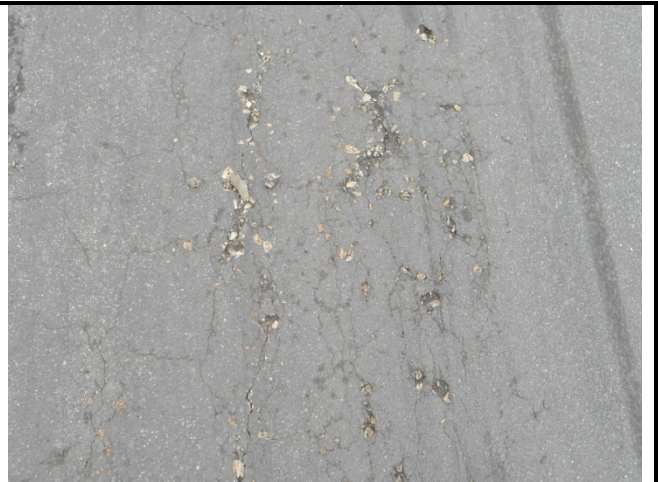
**Figure 4** Raveling of the Micro-surfacing

The block cracking pattern over most of the surface of the micro-surfacing can also be described as medium to high severity raveling. An example is shown in **Figure 4**.

The block shaped cracking pattern in the micro-surface is the result of different temperature coefficients between the micro-surfacing and underlying dense-graded cold mix asphalt; this is typically more evident with sand seals or coal tar applications. As noted, it did appear that a fine aggregate was used to produce the micro-surfacing.

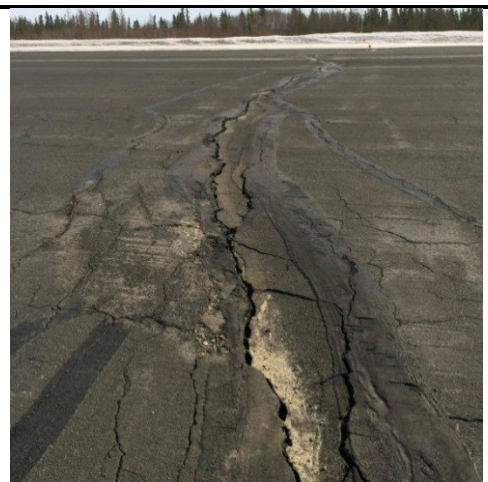
**Figure 5** Transverse Cracking on Runway 06-24

There are six high severity transverse cracks on Runway 06-24, two on Runway 14-32 and one on Taxiway B. **Figure 5** is a typical example from Runway 06-24.

Six high-severity transverse cracks were observed at various locations on Runway 06-24. Transverse cracks are the result of low temperature shrinkage in the asphalt pavement.

The transverse cracking on Runway 06-24 is much more severe than on those occurring on Runway 14-32 and Taxiway B. Therefore the recommended repair at each transvers crack location is as follows:

- Following the removal of the asphalt surface, remove the underlying granular base and granular fill to a depth of 1.0m.
- The bottom of the excavation should be 4.0m wide and perpendicular to the runway.
- The side slopes should be 10H:1V to provide a frost transition taper. The excavation should be backfilled using crushed granular base material.

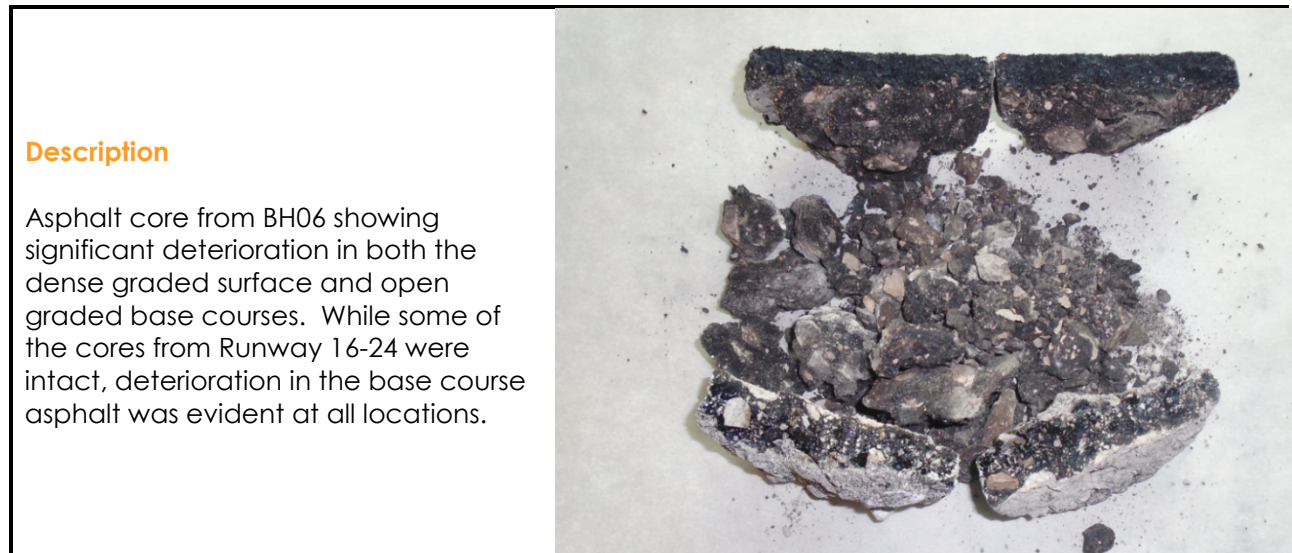
**Figure 6 Asphalt Core from Runway 06-24**

Runway 06-24 has an average asphalt concrete thickness of 112mm (range of 102mm to 127mm) and the granular base thickness averaged 366mm (range of 242mm to 496mm). At the test locations the asphalt pavement consisted of three layers: a thin (<10mm) layer of micro-surfacing, a well-graded surface course approximately 50 mm thick and an open-graded base course approximately 60 mm thick. Generally, slight to moderate asphalt stripping was observed in the surface course asphalt and severe asphalt stripping was evident in the base course asphalt.

A photograph of an asphalt core from BH06 on Runway 06-24 is presented in **Figure 6** which illustrates significant deterioration in the asphalt.

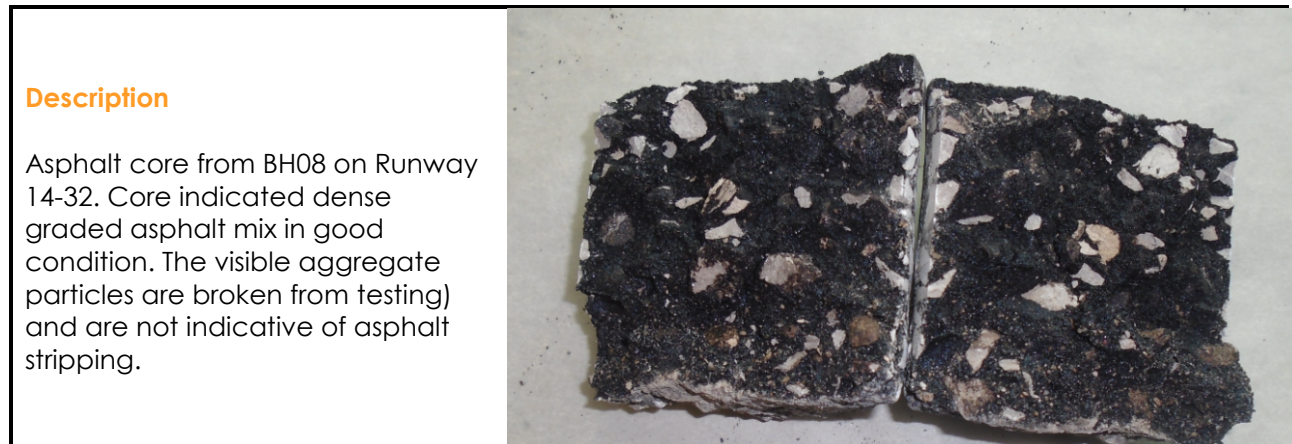
**Figure 7 Asphalt Core from Runway 14-32**

In general, the existing asphalt surface on Runway 14-32 is in good condition.

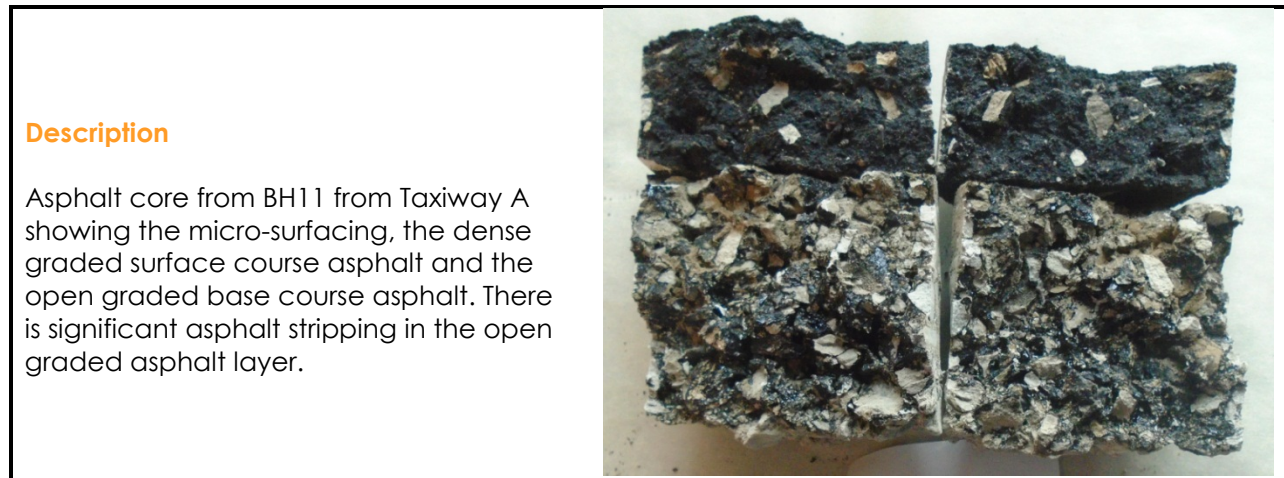
**Figure 8 Asphalt Core from Taxiway A**

While the open graded asphalt mix on Taxiway A is undergoing severe asphalt stripping, it has not yet deteriorated to the soft condition observed at the Runway 06-24 locations.

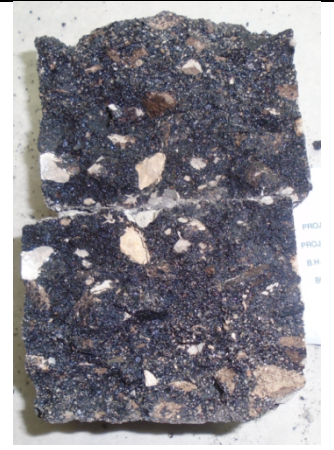
Asphalt core from BH20 from the portion of the Main Apron without micro-surfacing show the two layers of dense graded asphalt concrete. There is some slight to moderate asphalt stripping evident in the asphalt mixes.
