## Airport Management Conference of Ontario (AMCO)

Hoda Seddik, P.Eng.  
Associate Asphalt & Pavement Engineer

## 2008 Airfield Pavement Condition Survey for Municipal Airports

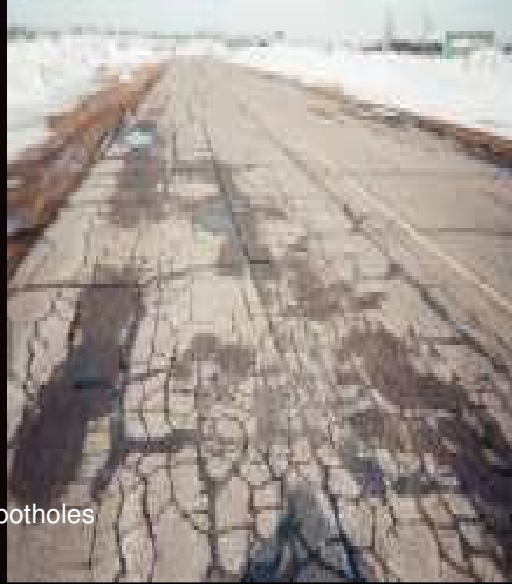
## Alligator Cracking

- It is a **load-associated defect** normally found in the aircraft wheelpaths.
- It can cause Foreign Object Damage hazard.
- Spacing between cracks is usually 50 to 300 mm.

Problems: eventually results in potholes

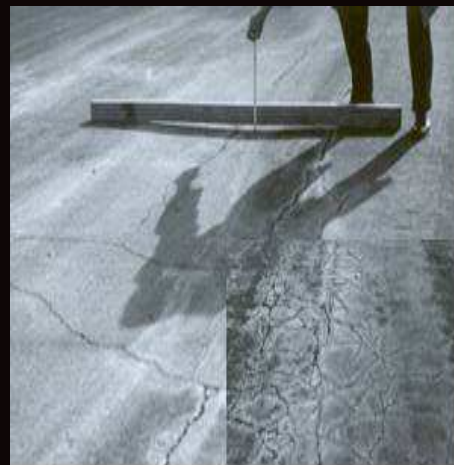
## Map Cracking

- Cracks intersecting at a spacing of 500 mm to 2 m.
- Map cracking **occurs only in the wheelpaths** (load associated) - **otherwise the defect is block cracking.**
- Caused by excessive deflection of the pavement under load.

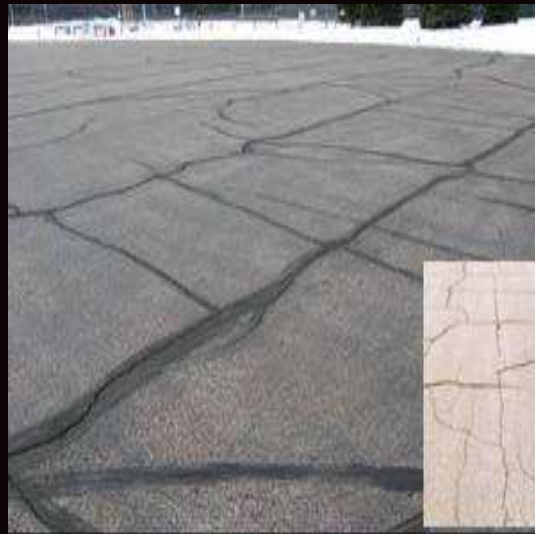
## Block Cracking

- Identified by intersecting transverse and longitudinal cracks forming blocks that may vary in size with a spacing of up to 3 X 3m.
- It is **not limited to wheelpath** locations (i.e. block cracking is **not load-related**) and will frequently occur throughout the entire pavement surface.

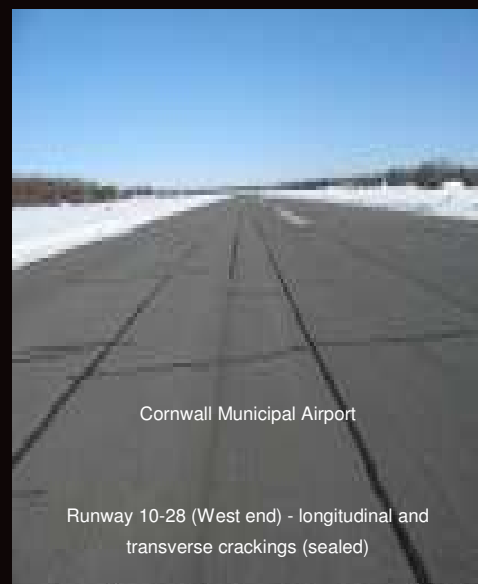
## Longitudinal Cracking

- Longitudinal cracks caused by repeated over-stressing of the wheelpath area by heavy aircraft traffic.
- Secondary cracking may eventually develop adjacent to the main crack which can lead to Foreign Object Damage (FOD) hazard for aircraft.

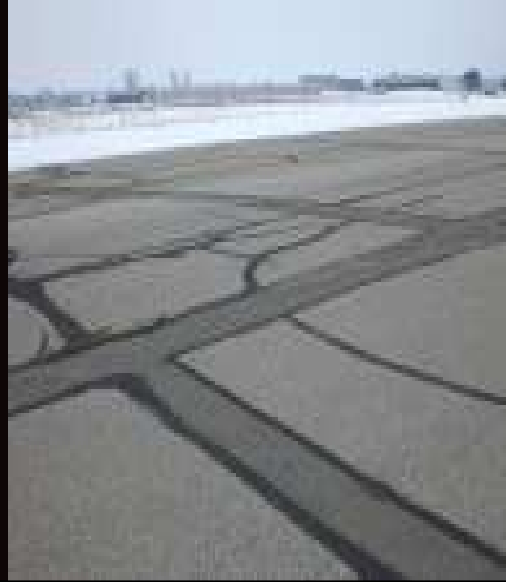
## Transverse Cracking

- Transverse, thermal cracks caused by cold temperature variation.

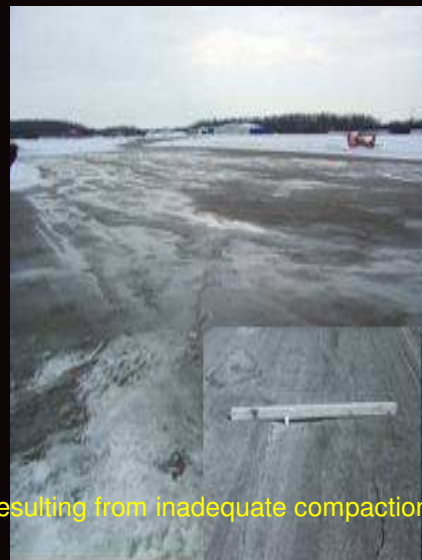
## Wheelpath Rutting

- Rutting is a **load-related depression found in the wheelpath area.**
- A visual check for rutting can be made by a straight-edge.
- Rut depths exceeding 40 mm are considered excessive.
- Ruts can cause problems with the directional control of aircraft should water accumulate in the ruts during rain and lead to hydroplaning problems.

**Possible causes: subgrade settlement resulting from inadequate compaction during construction**

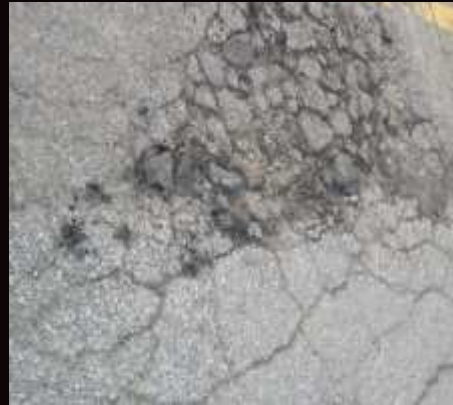
## Ravelling

- Ravelling is the disintegration and subsequent loss of the asphalt surface.
- It is evidenced by the pop-out of surface aggregates and/or the loss of surface fines from the asphalt mix.
- Severe cases representing a FOD hazard for aircraft.

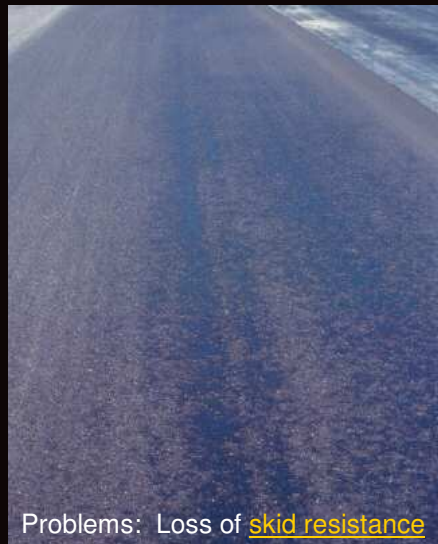
## Bleeding

- Bleeding is also accumulation of asphalt binder (cement) on the pavement surface - normally in the wheelpath areas.
- Bleeding can be caused by excess asphalt cement and/or insufficient voids in the asphalt mix, with the excess asphalt being flushed to the pavement surface by wheel loads during hot weather.
- Bleeding reduces friction required for aircraft braking and can become very slippery - especially when wet.

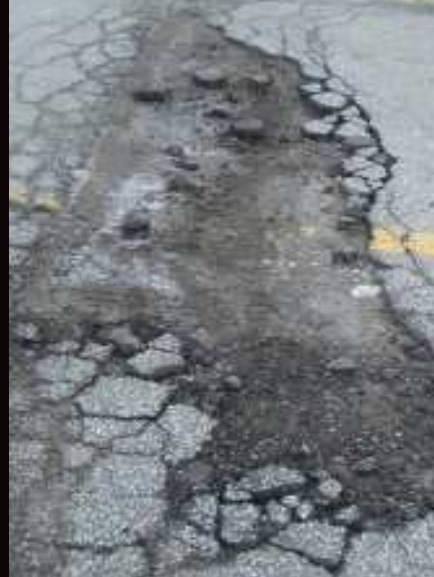
## Potholes

- The usual end result of structural deterioration is the pop-out of surface material which creates a FOD (Foreign Object Damage) hazard for aircraft.

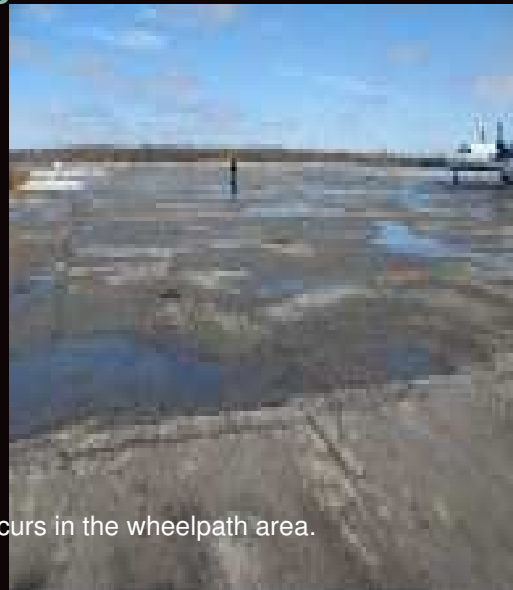
## Frost Heave Damage

- Frost heave is the vertical movement of the pavement surface during winter or early spring.
- Normally, only differential heaving is of concern.
- Frost heave is caused by ice lenses forming in a frost-susceptible subgrade soil when a source of subsurface water and freezing temperatures are present.
- Frost heaving is critical if it occurs in the wheelpath area.

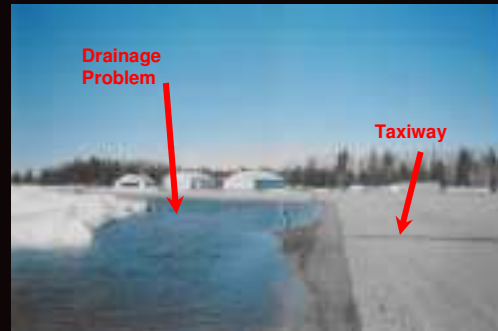
## Subgrade Settlement/Depression and Surface Ponding

- Subgrade settlement is a depression in the pavement surface, usually over a fairly extended area, and may occur anywhere in the pavement surface.
- Ponded water may represent a potential hydroplaning problem.

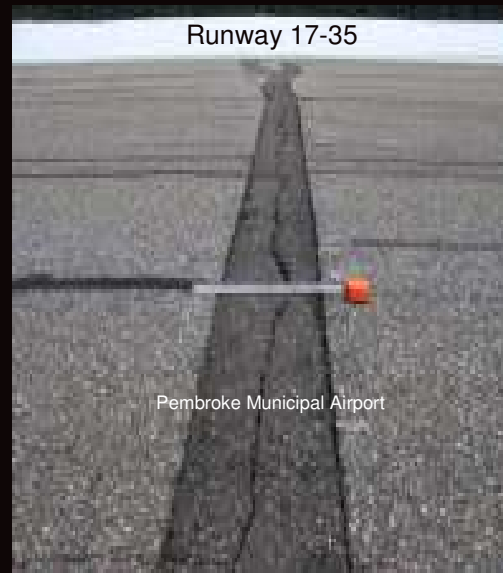
## Surface Patching

- Patching is localized area usually to correct a pavement structural defect or deficiency.

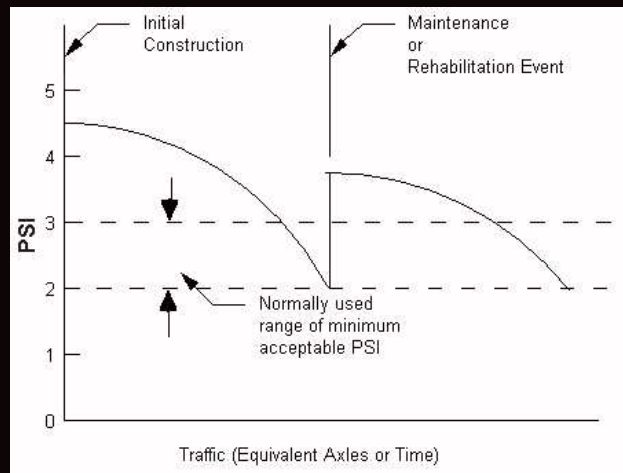
# Pavement Performance

The pavement deterioration is well explained by a deterioration curve as shown in the figure below.

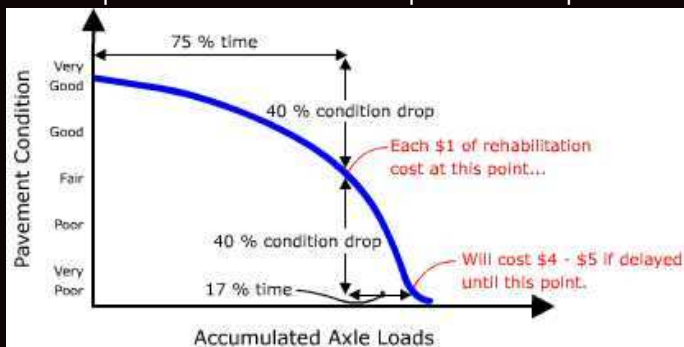
# Rehabilitation Strategies

- The worst is waiting until pavement has deteriorated significantly over its service life before initiating more costly resurfacing / reconstruction alternatives. It is estimated that \$1 invested early in a pavement's life cycle can save in excess of \$5 in the future.
- Notice that for the first 75% of pavement life, the pavement condition drops by about 40%. However, it only takes another 17% of pavement life for the pavement condition to drop another 40 percent.

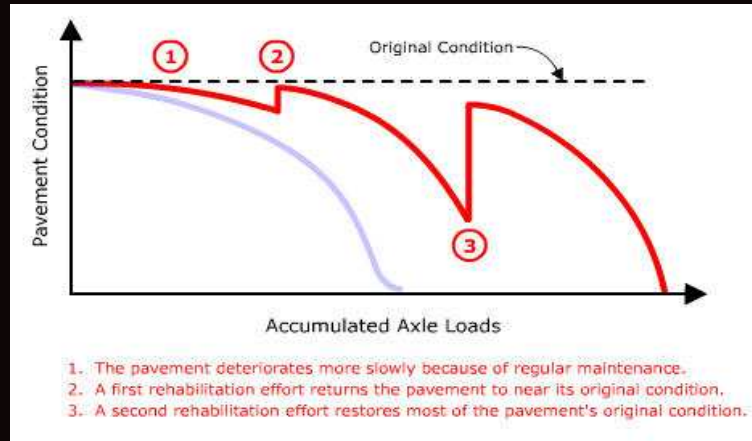
## Rehabilitation Strategies

- Timing of maintenance and rehabilitation actions can greatly influence their effectiveness and cost.

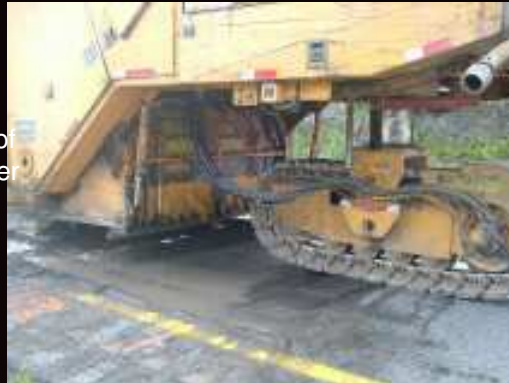
### Option: Milling & Resurfacing

This option involves cold milling/grinding the existing asphalt surface to a depth of 100+ mm.

**Typical Milling Machine**  
Tracks, Vacuum, Cutter Drum, Conveyor Belts

The milled areas should be tack coated and should conform to OPSS 1103, Type SS1. The milled depth should be replaced with a minimum of 1 lift of 60 mm asphalt concrete binder course.

A new surface course of 40 mm hot mix should be placed over the new binder course.
